Notes from the Field

3/4/2011: Log Barn in Livingston County

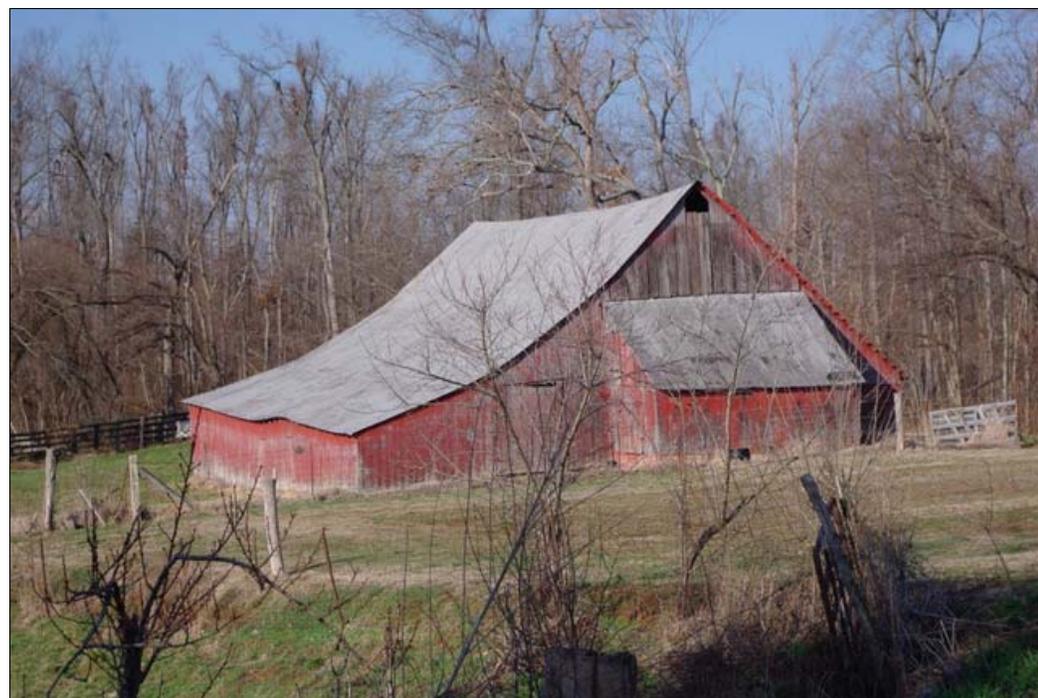
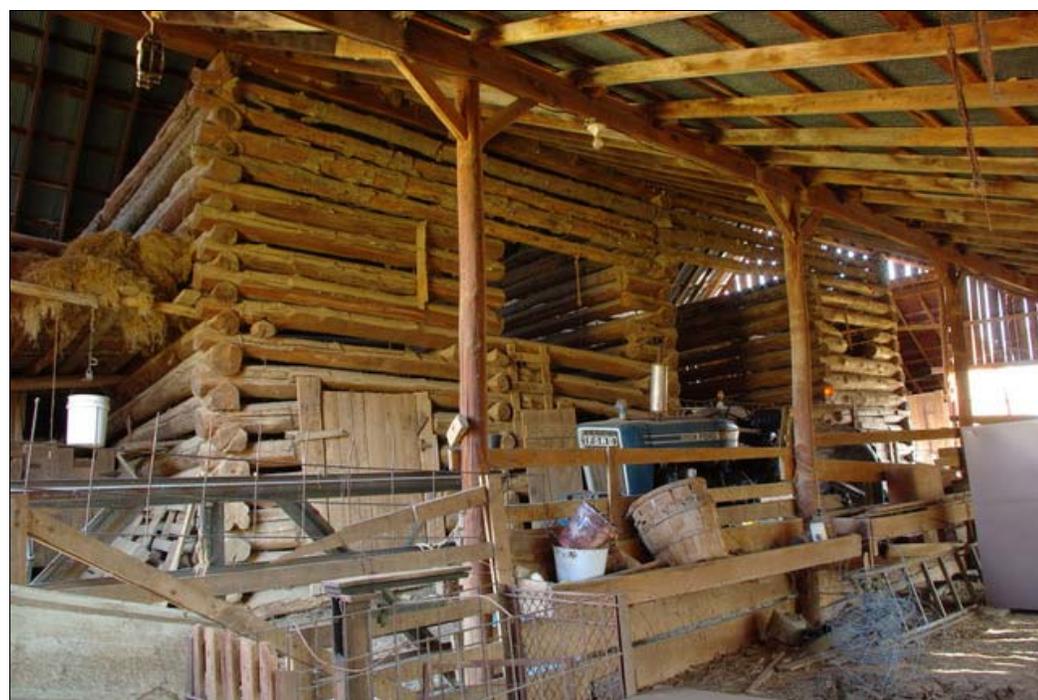
One of our current Survey and Planning grants went out to Preservation Kentucky to survey rural sites in Crittenden and Livingston Counties. Architectural historians with the Kentucky Archaeological Survey are conducting the fieldwork and research. We recently travelled out there to get a look at the project area and hold two public meetings to kick off the project. One of the highlights of our trip was this wonderful double crib log barn in Livingston County, probably from the late 19th century.

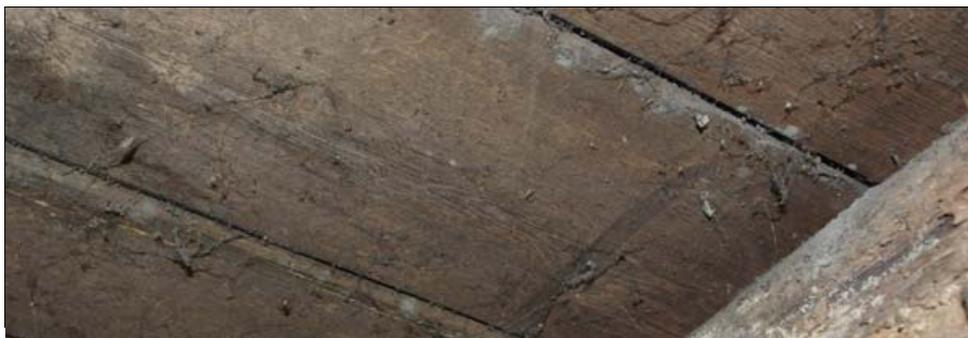
When you are trying to figure out the date of an old house, begin with the structure, then think about the style. If you can get into the basement or the attic, some of the best clues can be found there. How are the joists and rafters cut and joined? What sorts of tool marks are visible? The detail below is from a Shelby County house that was heavily remodeled in the later 19th century, and modernized again in the 20th, but the bones of the house reveal its early 19th century origins. In the picture, we are in the cellar looking overhead at a log floor joist that has been hewn flat on the top surface. The floorboards do not have any conspicuous saw marks, suggesting they came from a mill, but they have been undercut where they lie on the joists, to level the floor surface above.

Early floor boards varied in thickness. In locations where their undersides would not be commonly visible, builders only planed the top surface of the boards. The bevel along the edges of the floorboards follows a gauge line struck a common distance from the top edge along the sides of each board. This tells the carpenter how deeply to undercut the board at the joist to level it - thus, these are called "gauged and undercut" floor boards. You might find examples of this as late as the 1830s-1840s, but it mostly ceases by about the 1820s. After that, the mills produce machine planed floorboards of even thickness so there is no need to level them in this way. You are also more likely to find the floor joists hewn or sawn into a rectangular profile in later houses.

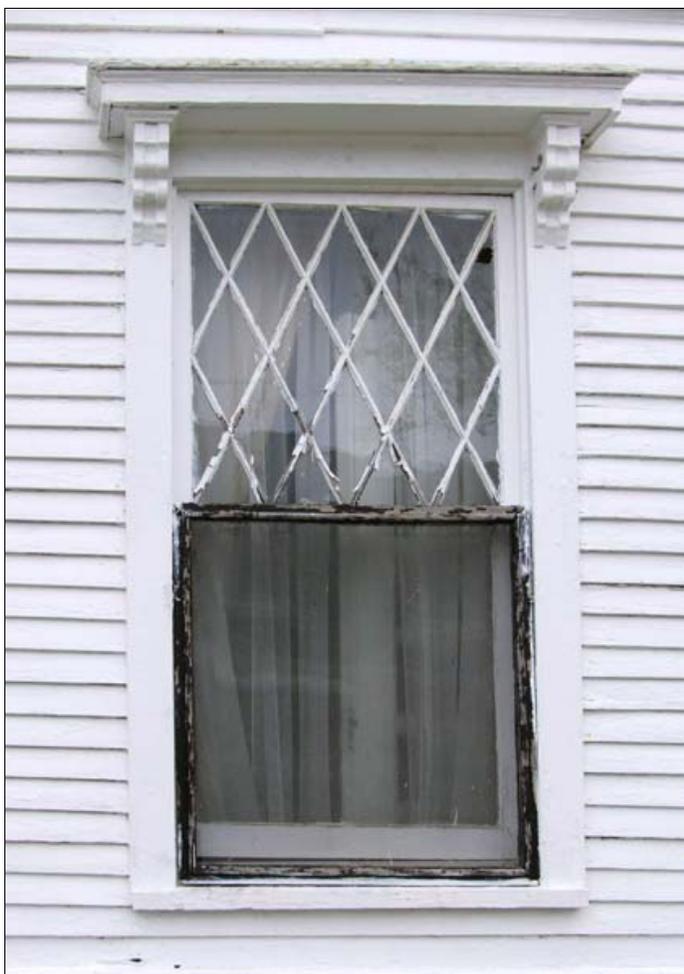
Pictured below is a beautiful window from a house in Mackville.
