Generalized Geologic Map for Land-Use Planning: Menifee County, Kentucky

Daniel I. Carey
Kentucky Geological Survey
Peter Eclow
University of Kentucky

Map and Chart 159

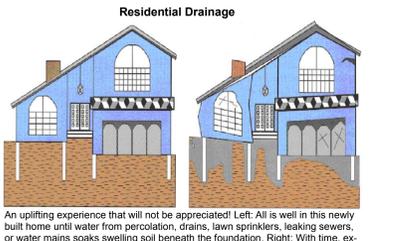
Residential Drainage

An uplifting experience that will not be appreciated! Left: All is well in this newly built home until water from percolation, drains, lawn sprinklers, leaking sewers, or water mains soaks swelling soil beneath the foundation. Right: With time, expanding soils exert several tons per square foot of pressure on the foundation and shallow pilings. Without remedial measures, the house actually become deformed, and shatter masonry and windows. Remedies vary from mere maintenance that keeps drainage away from the house to expensive reconstruction of foundations. Prior site planning that takes geology into account is always preferable to dealing with problems after a structure is built. From AUPS (1993).
